External Water-Bar Installation – National Starch, Karasin

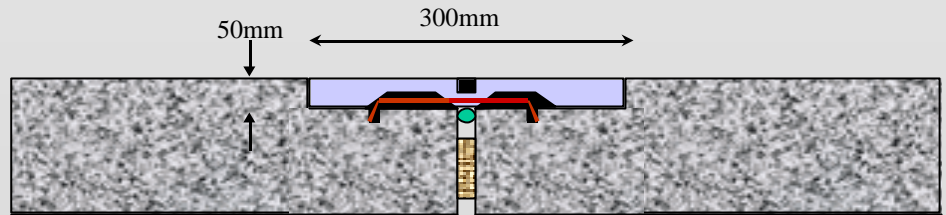
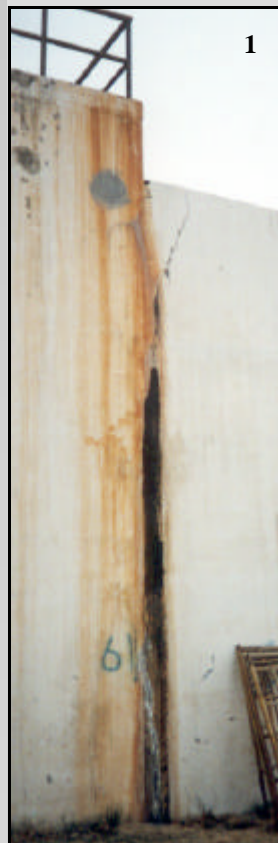
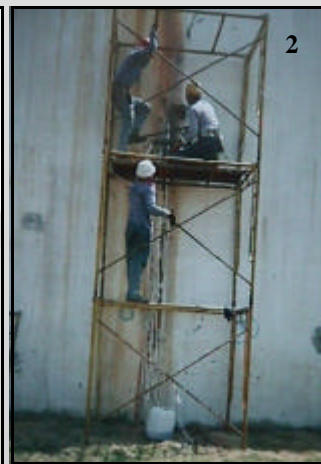
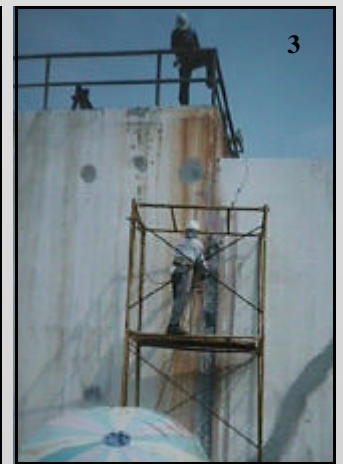
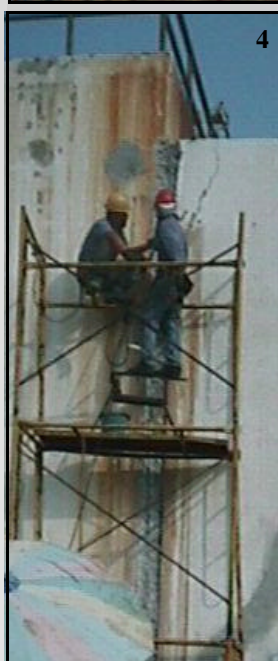
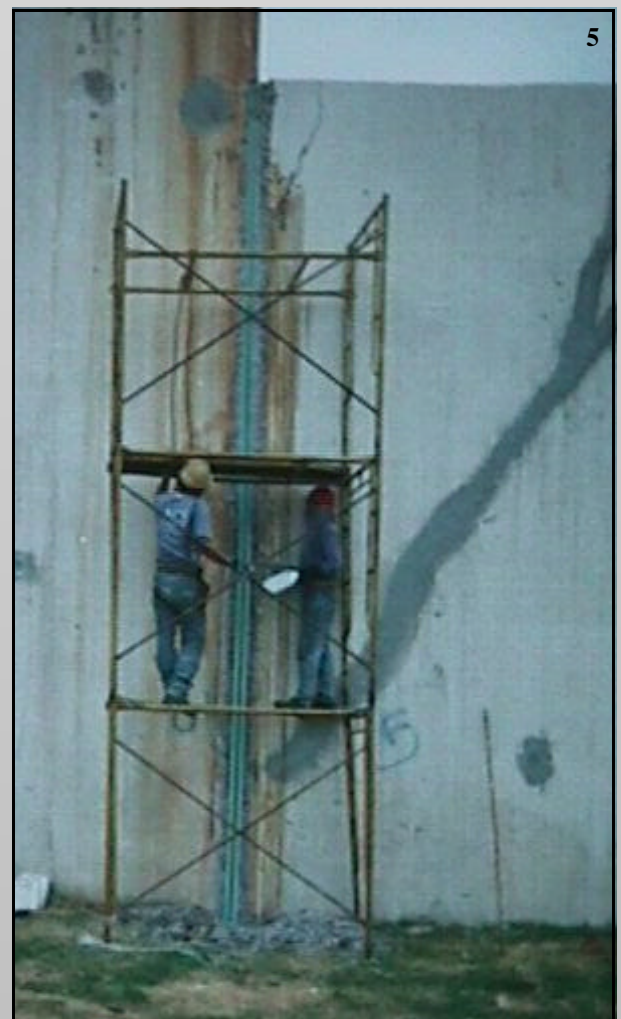
Repair Sequence Key

Whether damaged during installation, incorrectly detailed or omitted all together, the failure of the waterproofing at the main construction joint between two primary waste water treatment tanks caused major problems for National Starch maintenance staff in Karasin.

- 1 Failed construction joint
- 2 First pass PU injection
- 3 Forming chase
- 4 Second Pass PU injection
- 5 Installation
- 6 Surface repair

The solution proposed by Hammersmith was the post installation of the Dila Joint Tape System from Messrs. Vandex International
