## Controlled Demolition of Interconnecting Stair - ABN Amro Bank

Project Title	Controlled Demolition of Interconnecting Stair
Client	ABN Amro Bank
Project Details	Removal of all architectural finishes, Installation of temporary support structure, demolition of stair by stitch drilling and waste removal
Completion Date	December, 2002

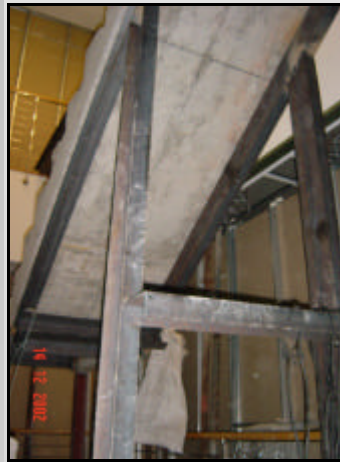
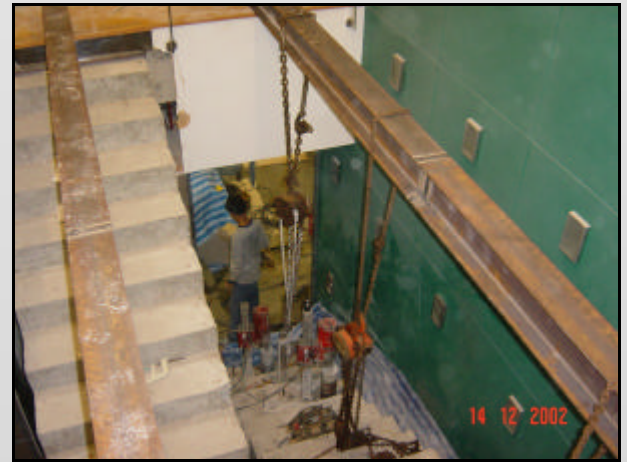
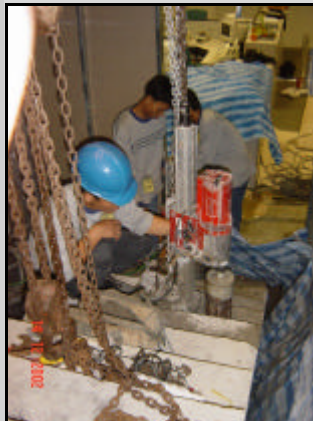
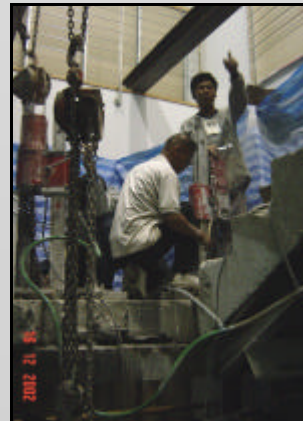
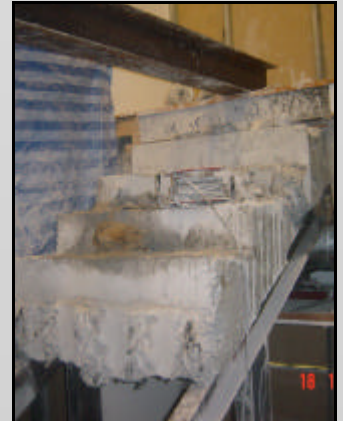
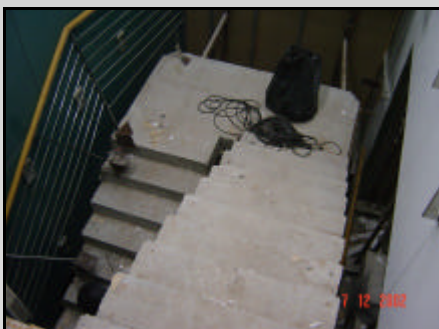
Working only at nights and weekends in this extremely confined space Hammersmith installed in excess of 4,000 kg of temporary structural steel support frames and removed the stair by stitch drilling in 10 working days
