PROJECT REFERENCE

Siam Strip Mill / Hecket Multiserve

Heavy Duty Repairs to Expansion joint Shoulders and Road Ways

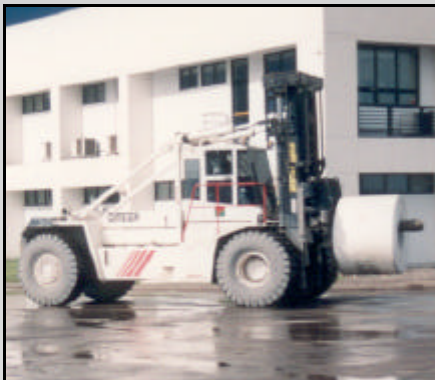
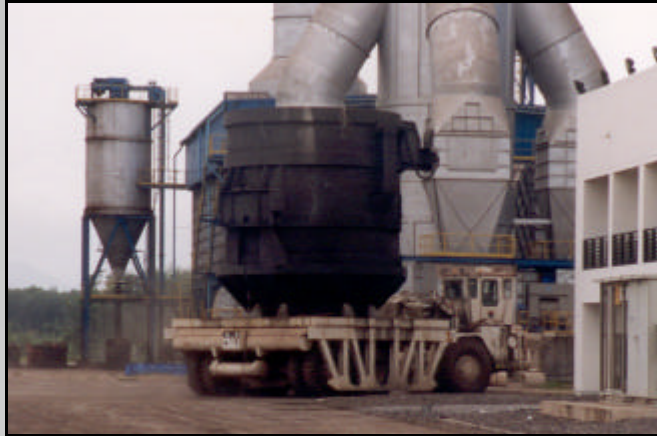
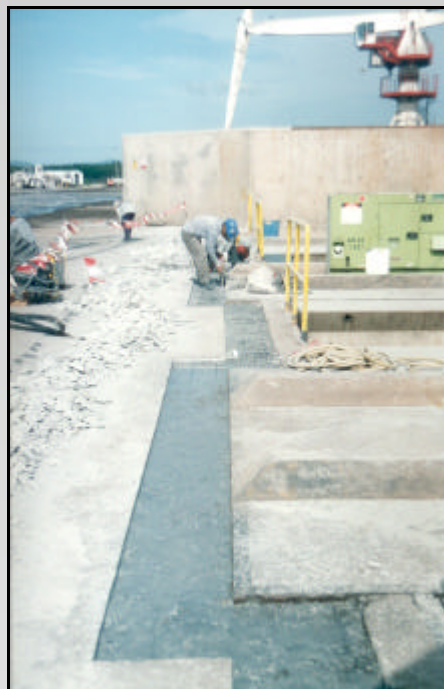
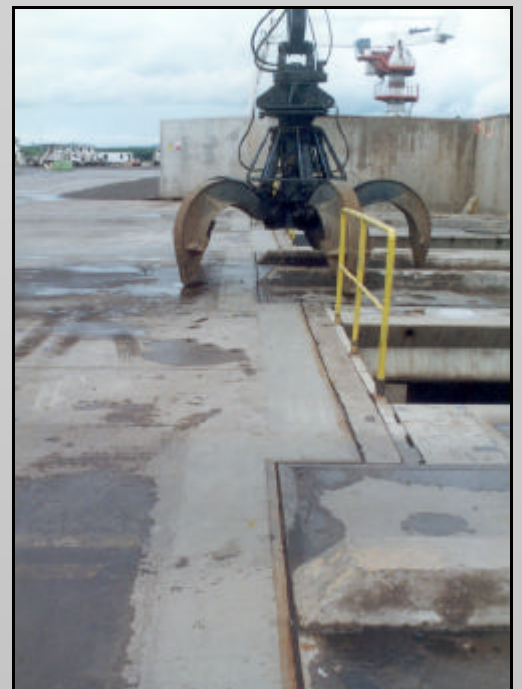
Extreme loads from vehicles with axle weights up to 196,000 kg caused severe damage to expansion joints and general concrete surfaces in the scrap metal storage area of Hecket Multiserve at Siam Strip Mill.

The selection of the Densitop repair system, comprising steel fiber reinforced cementitious materials with compressive strengths in excess of 150N/mm, provided the client with an otherwise unattainable solution to a serious problem

Approximately 500m² of expansion joint shoulder repair and reinstatement of new jointing system
