Demolition of Bank Vault – Standard Chartered Nakornthon Bank

Project Title:	SCNB Main Branch, Sathorn Road– Demolition and Structural Alteration Works
Client:	Standard Chartered Nakornthon Bank
Project Details	Extraction of Safe Door for re-use, Controlled demolition and removal of “Cash Storage Vault” General demolition of architectural finishes
Completion Date	January 2001

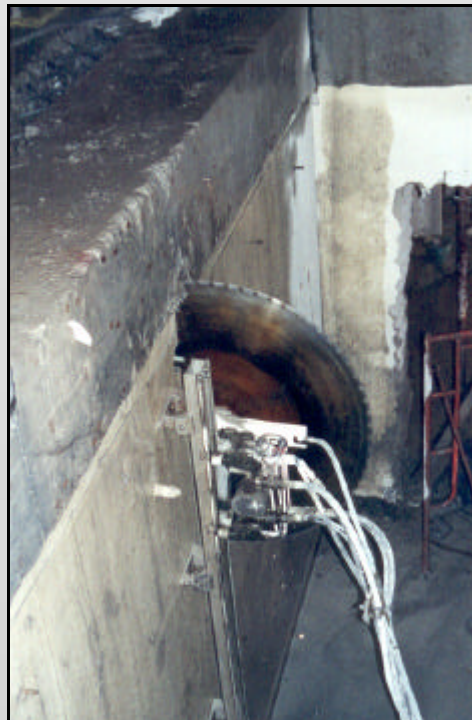
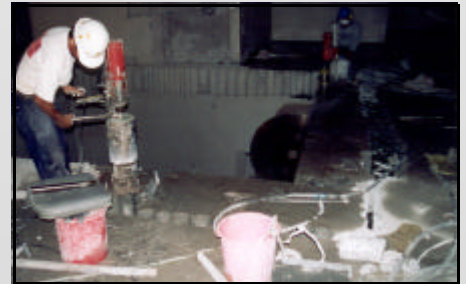
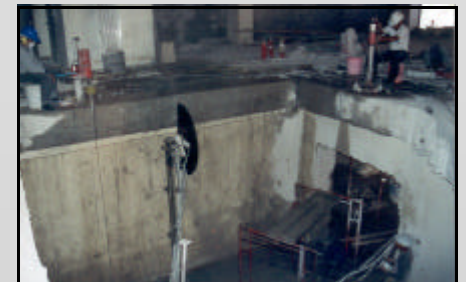
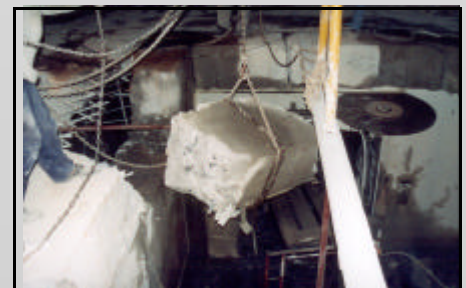
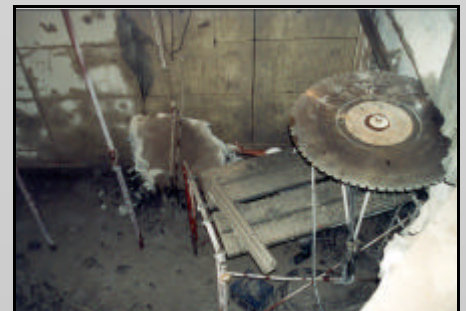
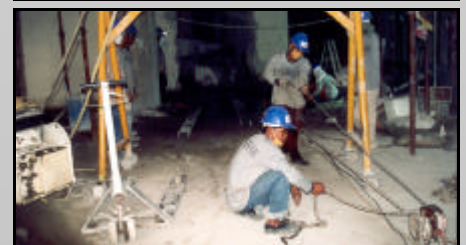
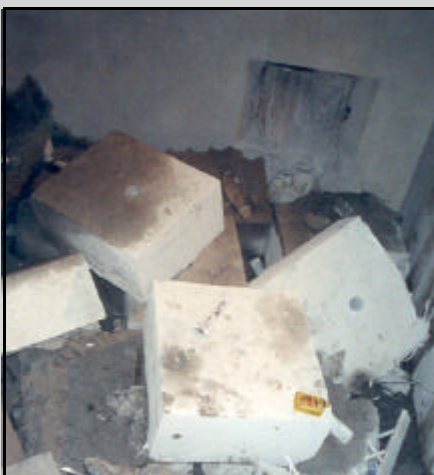
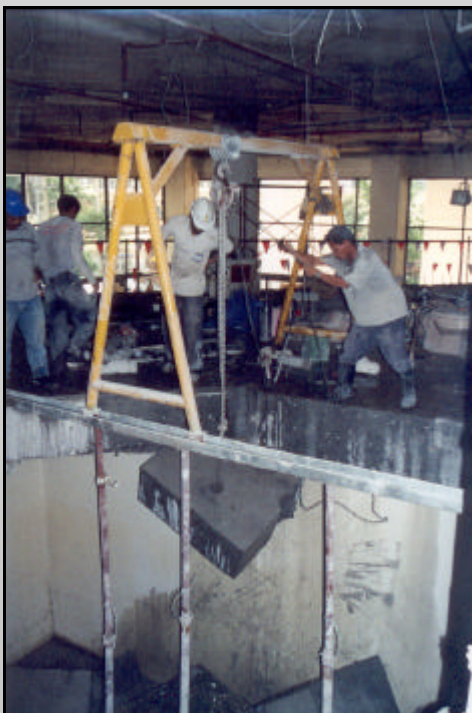
In the four week contract period all existing finishes were stripped out, the vault door “surgically” removed for re-use and the heavily reinforced vault structure cut by diamond wall sawing and stitch drilling into app. 60 No. 1000 kg pieces for disposal.
